## Motorola Mitrek front end casting repair by Karl Shoemaker

### Introduction:

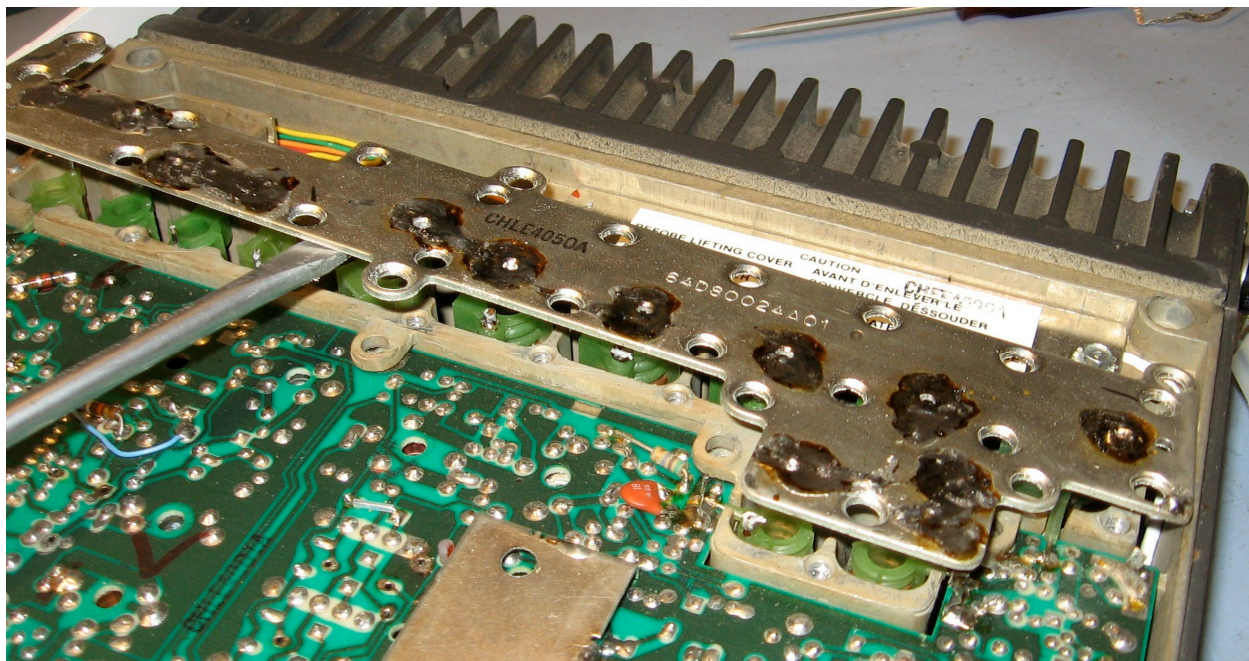
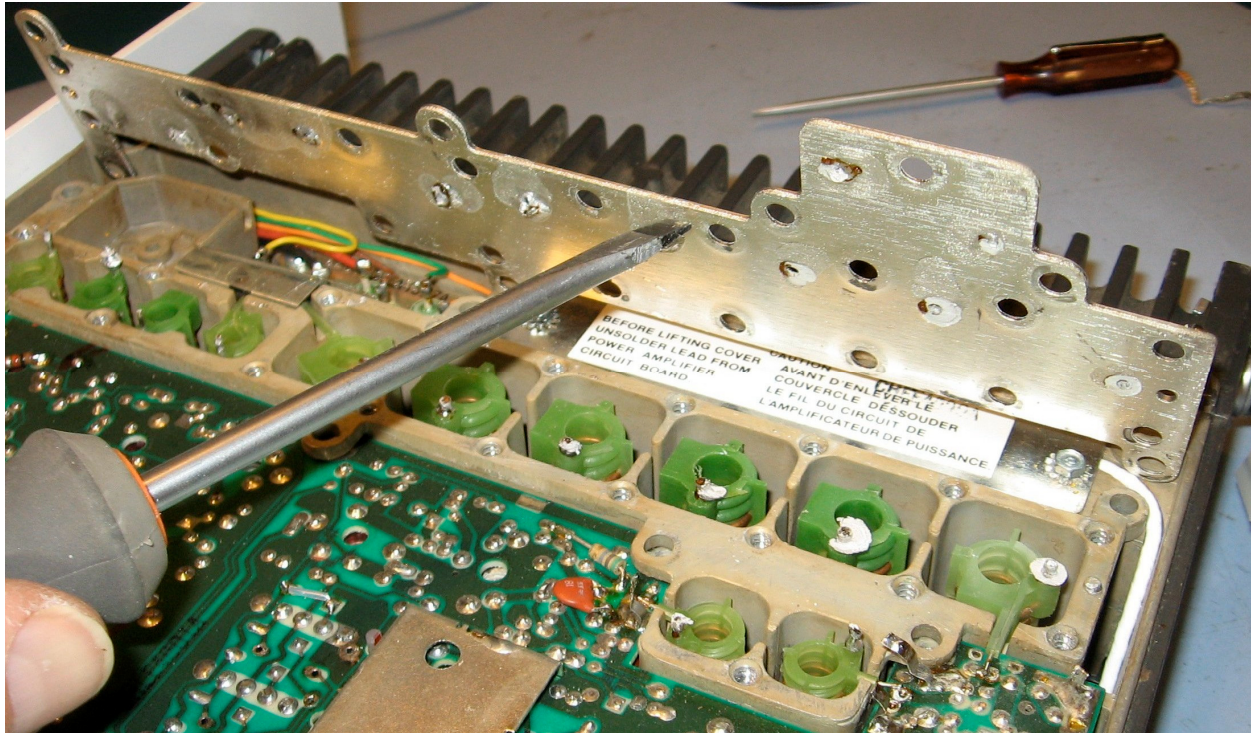
To remove the cover you will need a rather large iron in the 150w (or higher) area so there is enough heat to melt the solder connections in a short time. Even though the coils (inside) are supported with good plastic type forms they do have a limit from heat exposure (they are not teflon, etc.).

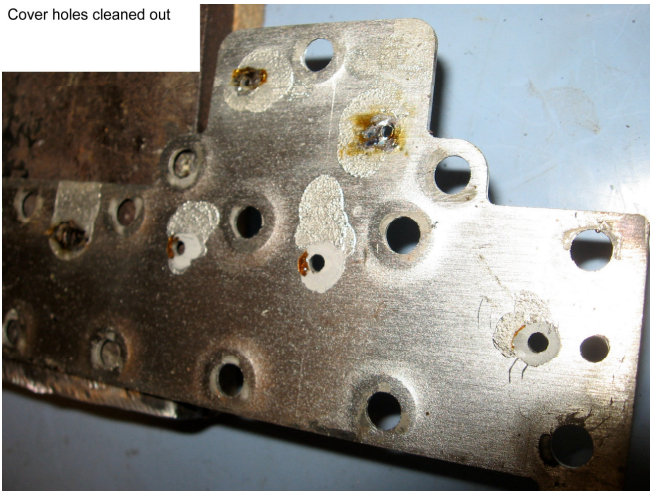
Cover holes cleaned out

Next, clean the excessive solder around all the holes. This will allow easy re-installation of the cover, later. Shown below is the in and outside of the cover.

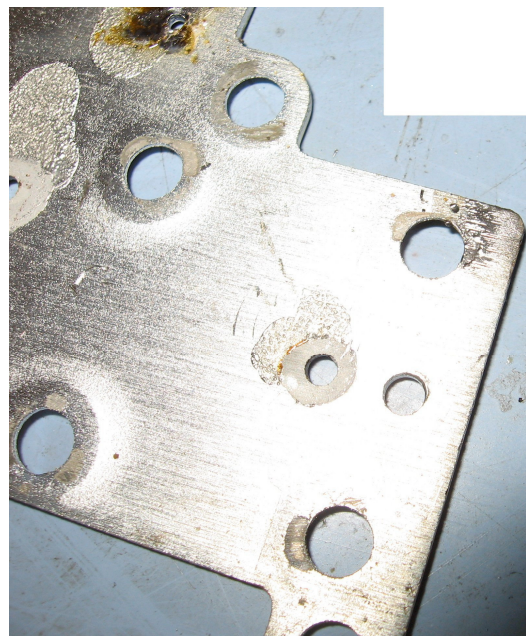
Using a "dremel" you can clean/polish the surfaces of the cover that touches the casting's edges. This may eliminate the PIM issue. On the right shows the result.

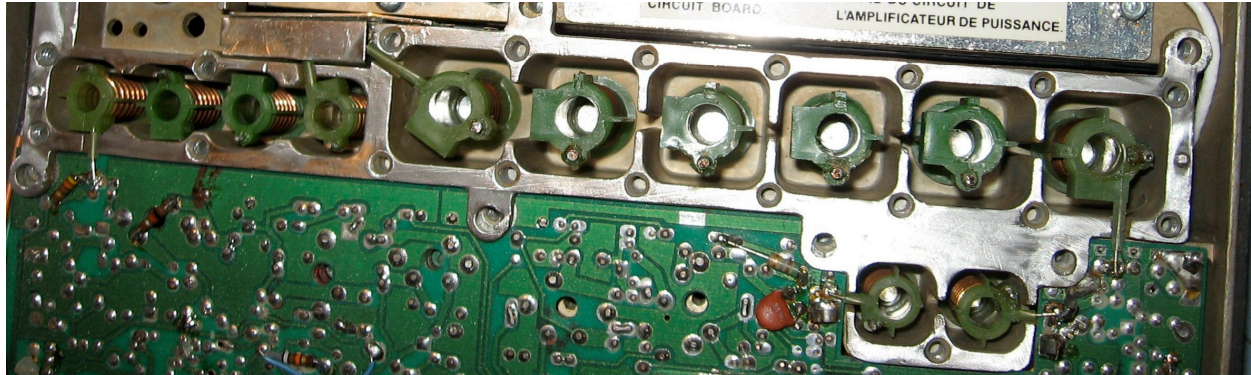
Here's the overall view of the coils and how they sit in the casting. The 4 on the left are the transmitter exciter filter (that feeds the PA section). The 6 in the middle are the receiver's "front end"; with the far right being one part of the mixer. The 2 on the bottom are part of the LO's multiplier section.

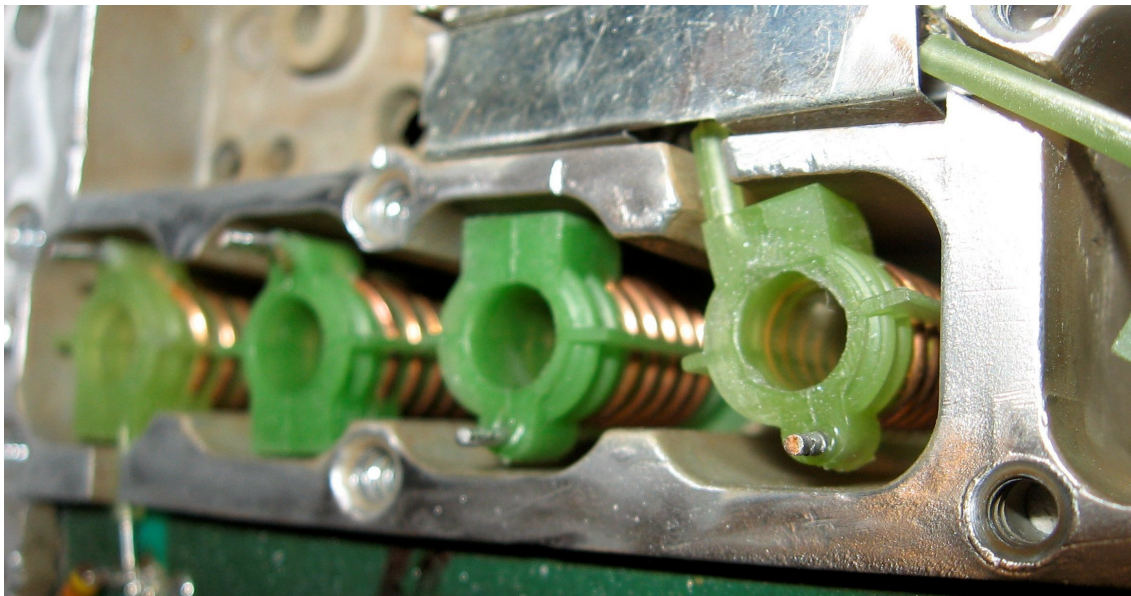
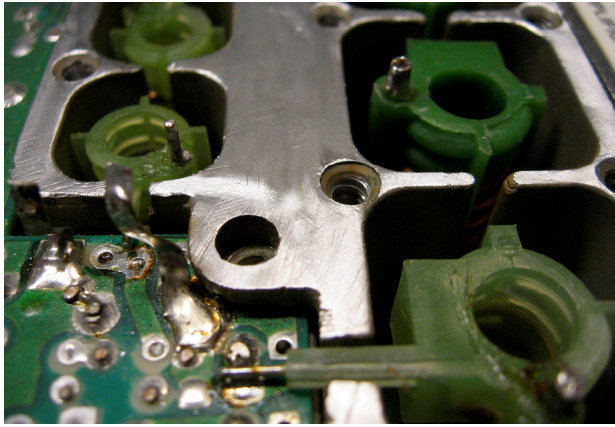
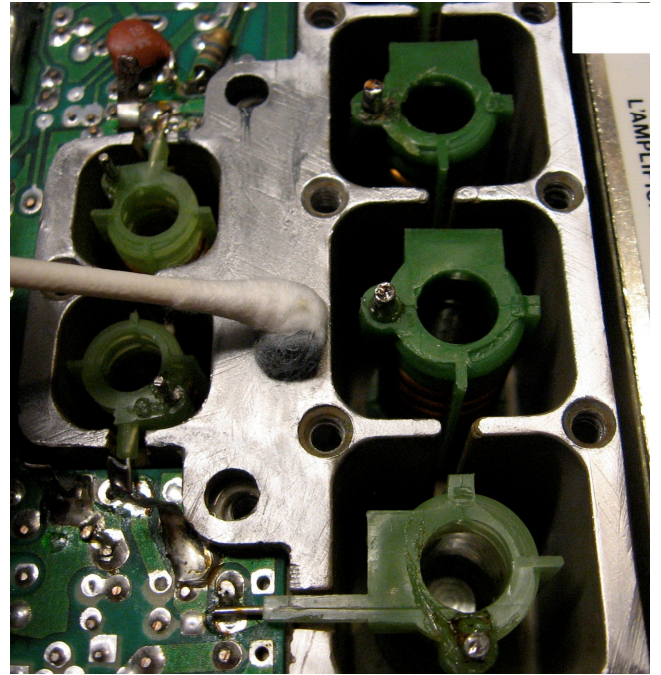
Here's a close-up of a coil's lead that was cleaned up of excessive solder. Note the edges of the casting have also been polished to remove any source of corrosion and PIM issues. Do this for the cover, too. Also, clean and blow out any debris that may have lodged on the bottom of the filter cavities. This will also clean out any "whiskers" that might have "grown" inside the cavities. This is a phenomena that happens with other brands of radios (GE Mastr-II for example). In this case there is enough (presumed) chemical reaction to the metals to cause "crystals" to form and grow across the cavity and "short" things out, causing complete failure to specification performance. It's unknown if it happens with this radio (at time of the research by the Author).

After the casting edges are cleaned and polished you can optionally apply a very thin coat of “interface” compound that solves the dissimilar metal corrosion issue. Using a Q-tip apply it on the casting anywhere it would come in contact with the cover. Apply it to the cover in the same areas. Make sure you don’t use the copper content type of compound because it would compound (pun intended) the PIM problem.

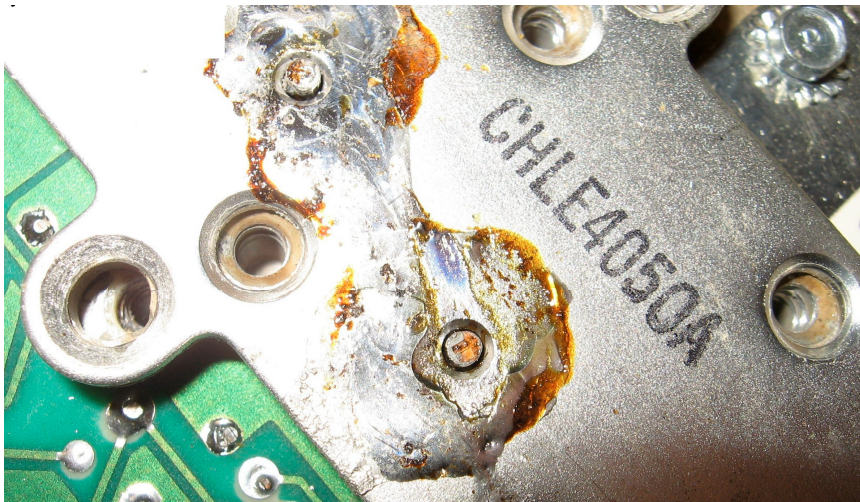
It’s a good idea to place the cover back down on the casting to verify all the coil leads are clear, and enter all the associated cover holes. This close-up shows excellent lead placement and clearance. Ideally, each lead should slightly protrude out of the cover for easy bonding when soldering to the cover.

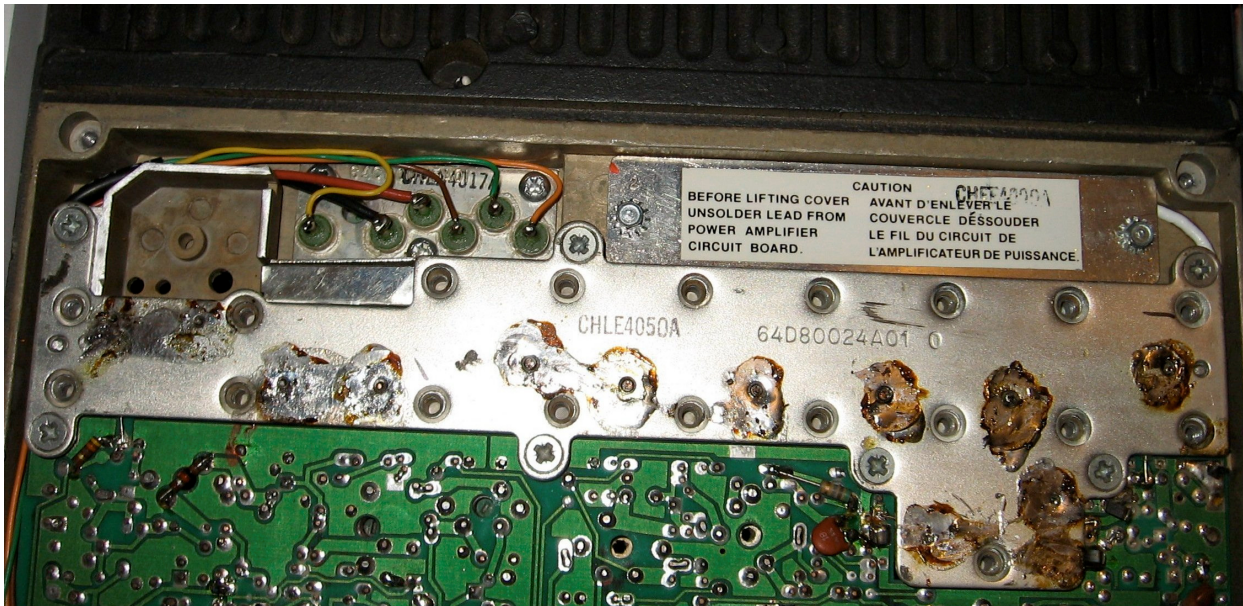
Starting with the 7 (longer) outside screws, secure the cover to the casting as shown. If you removed the I/O pins (will move the casting) you will have to hold the casting with another hand, so the screw holes line up to start the screws. Once the 7 screws are in place the cover will stay in the correct position.

Then install the 19 (short) screws. Set the 26 screws with medium torque. The Author uses his experienced hand to work this with the (pozi-drive) screwdriver. If this is your first time you may obtain a calibrated wrench. It's unknown what the spec is; common sense will tell you not to over tighten them. Another tip: these screws easily get cross-threaded when starting. It will take a special "feel" to get around that issue so they go in with little resistance in the start of the threading.

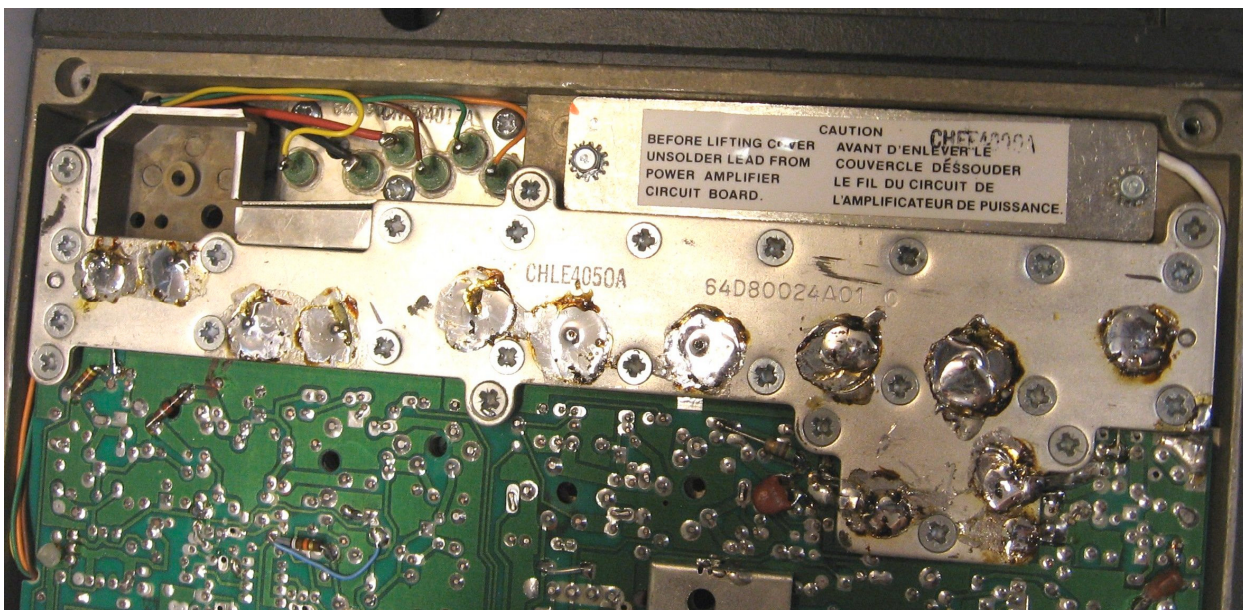
Solder the 12 coil leads to the cover's holes, the 3 ground straps to the cover and the 4 I/O pins (if needed) It's your choice whether to clean off the rosin. Generally, the Author leaves it if it's not excessive. This shows the completed task of the Mitrek's RF casting front end and filtering section.

Finally, tune the radio per the procedure to check performance.
