## Motorola Mitrek front end casting repair by Karl Shoemaker

### Introduction:

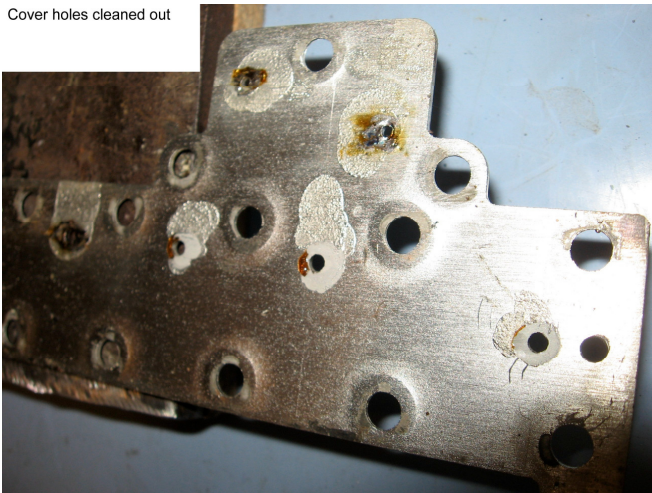
Cover holes cleaned out

Next, clean the excessive solder around all the holes. This will allow easy re-installation of the cover, later. Shown below is the in and outside of the cover.

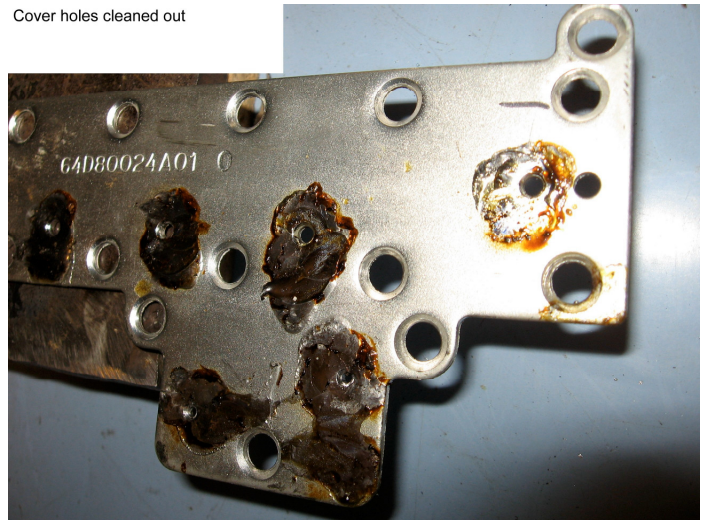
Cover holes cleaned out

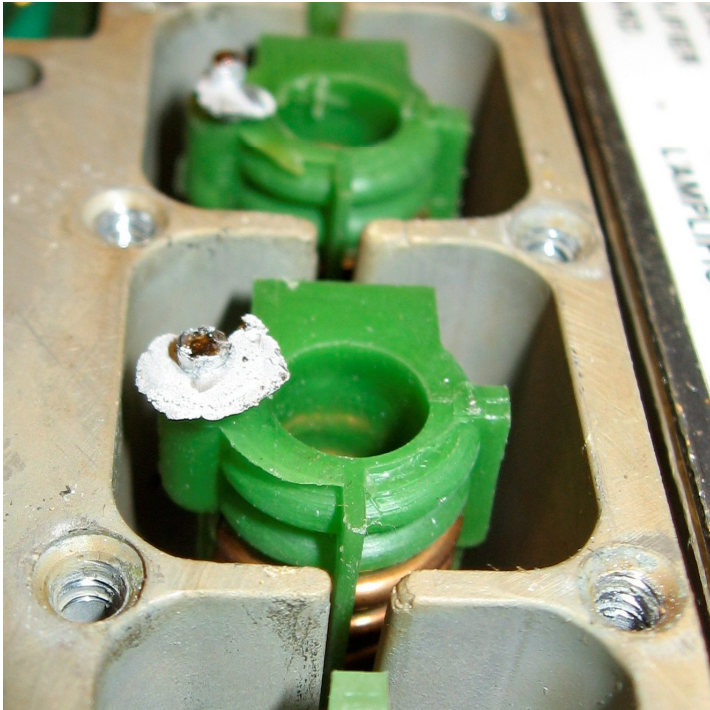
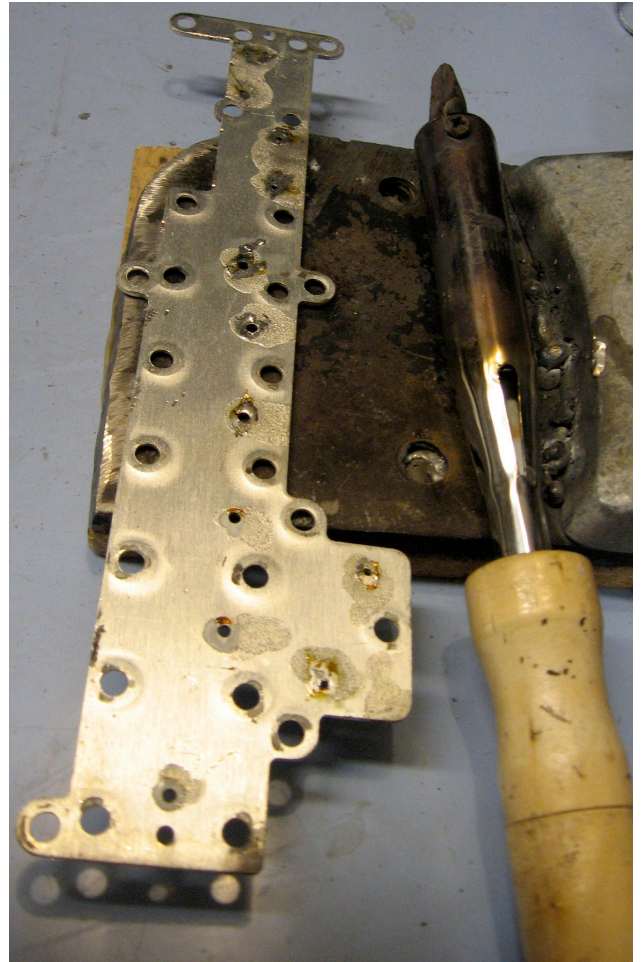
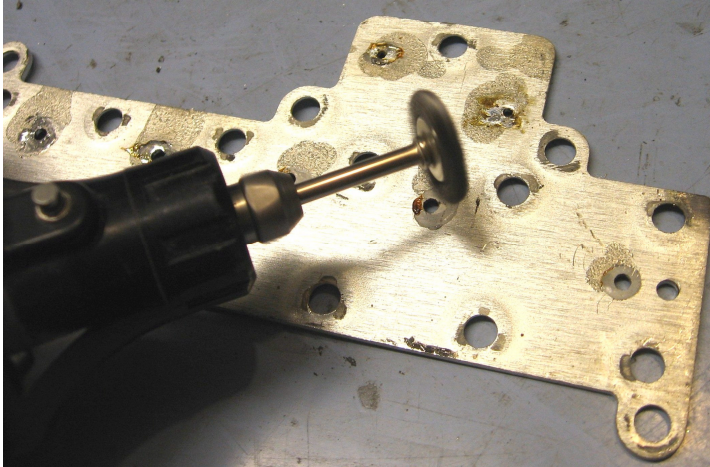
Some of the coil leads will have leftover solder as well, so they will need to be cleaned up. Using a sucker or wick helps. The cover can be cooling off while you perform this task. Note the large iron used for the removal task of the cover, but not for wicking the coil leads.

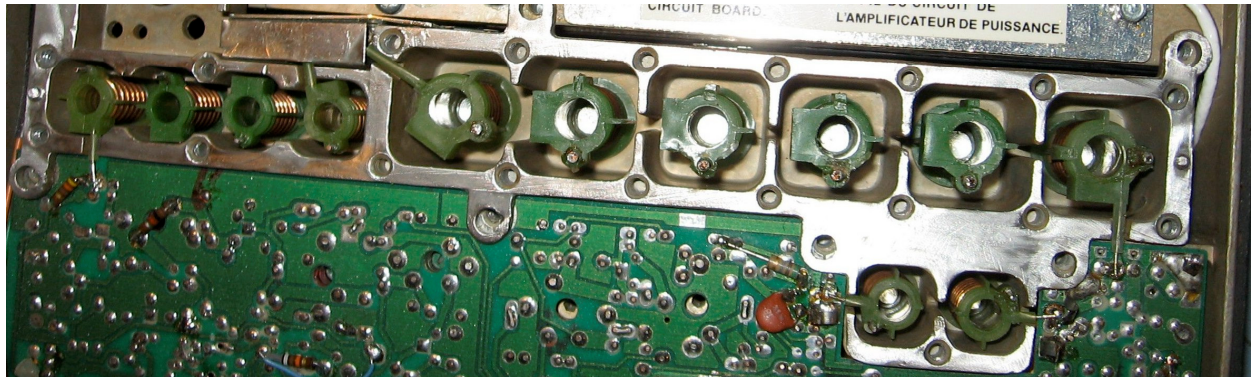
Here's the overall view of the coils and how they sit in the casting. The 4 on the left are the transmitter exciter filter (that feeds the PA section). The 6 in the middle are the receiver's "front end"; with the far right being one part of the mixer. The 2 on the bottom are part of the LO's multiplier section.

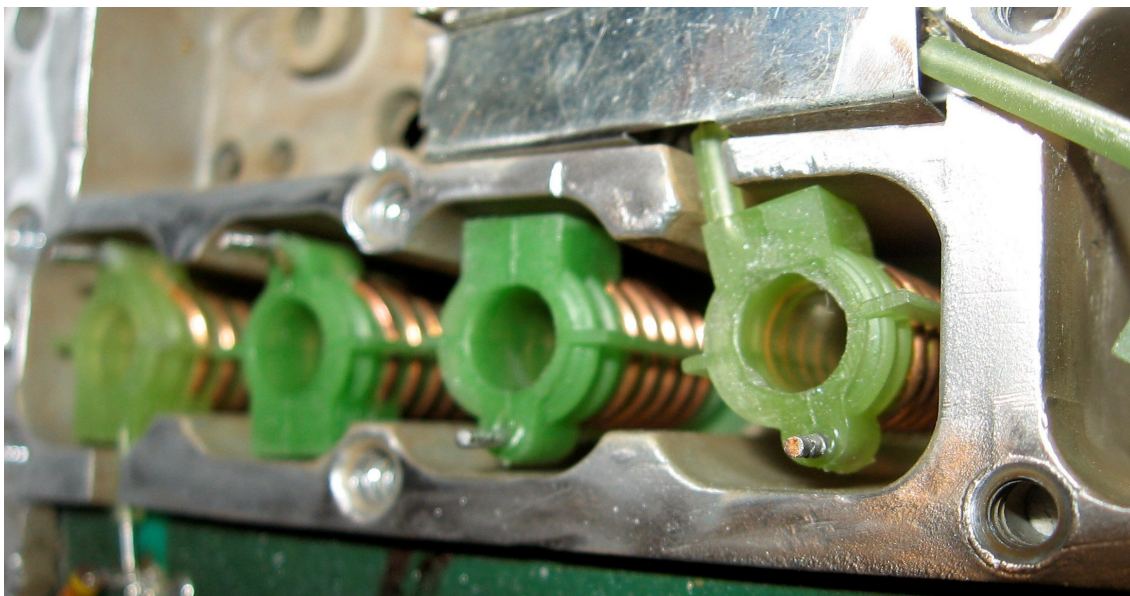
Here's a close-up of a coil's lead that was cleaned up of excessive solder. Note the edges of the casting have also been polished to remove any source of corrosion and PIM issues. Do this for the cover, too. Also, clean and blow out any debris that may have lodged on the bottom of the filter cavities. This will also clean out any "whiskers" that might have "grown" inside the cavities. This is a phenomena that happens with other brands of radios (GE Mastr-II for example). In this case there is enough (presumed) chemical reaction to the metals to cause "crystals" to form and grow across the cavity and "short" things out, causing complete failure to specification performance. It's unknown if it happens with this radio (at time of the research by the Author).

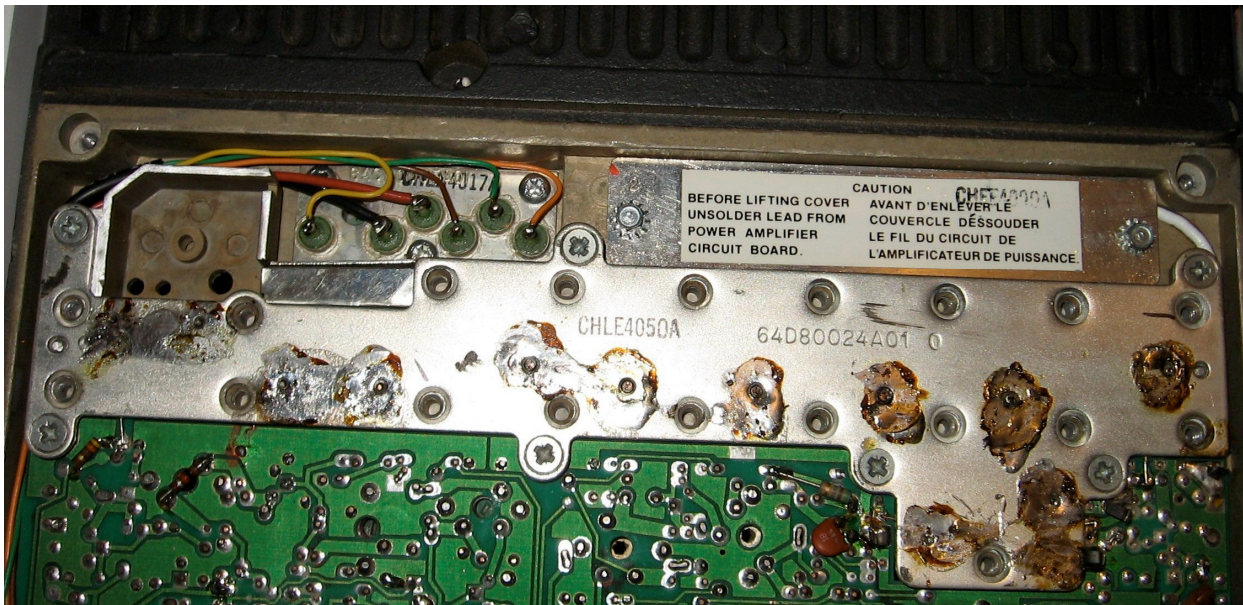
The lower picture shows the completed task of the Mitrek's RF casting front end and filtering section.
