Micor "Compa" transmitter by Karl Shoemaker

Introduction:

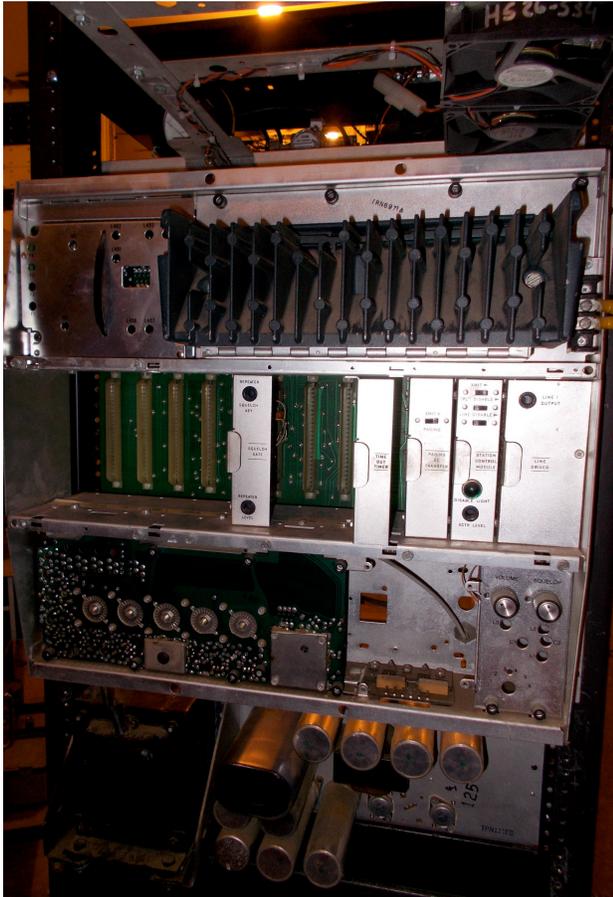
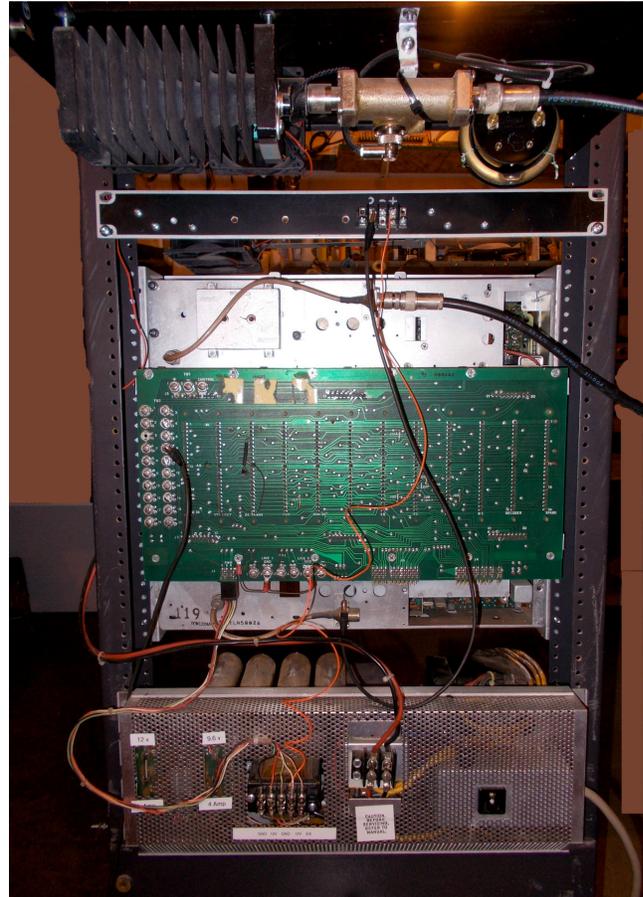
During a repair effort for a site, a spare was brought up from the SRG bone yard to test it. This is the unified chassis version. Most of the stations cards and receiver parts were left out because of the focus on the transmitter (at this time) was documented. The test set is a shorten rack mounted on a box (to house another supply) on wheels. This makes easy maneuvering around the shop.

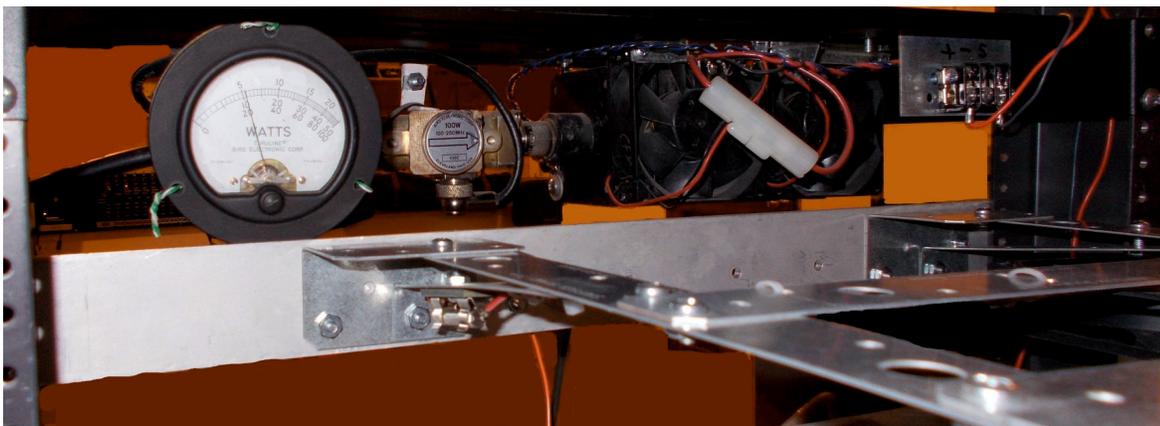
Here shows the meter and load for testing the transmitter. Unfortunately, the meter is in linear therefore, conversion needs to be done back to log for proper documentation.

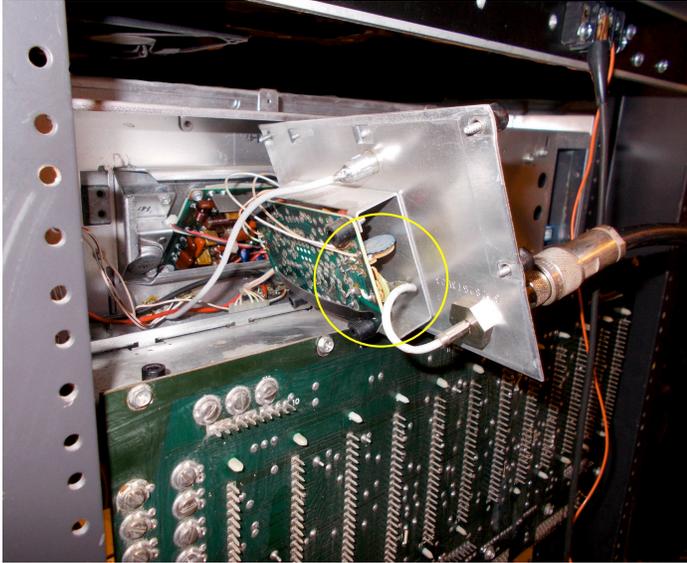
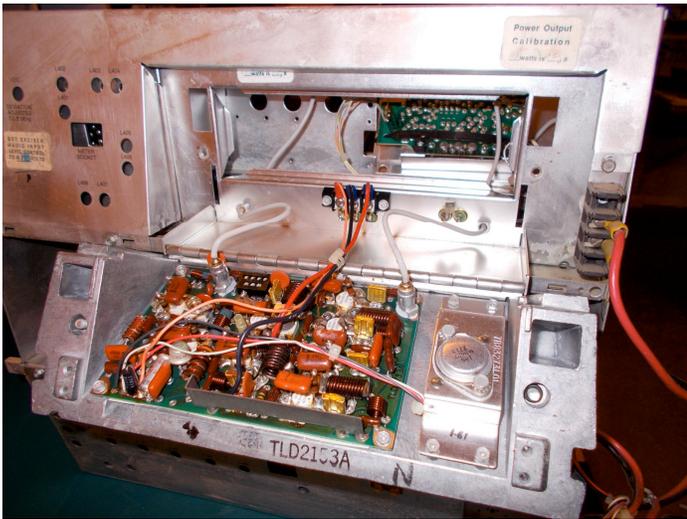
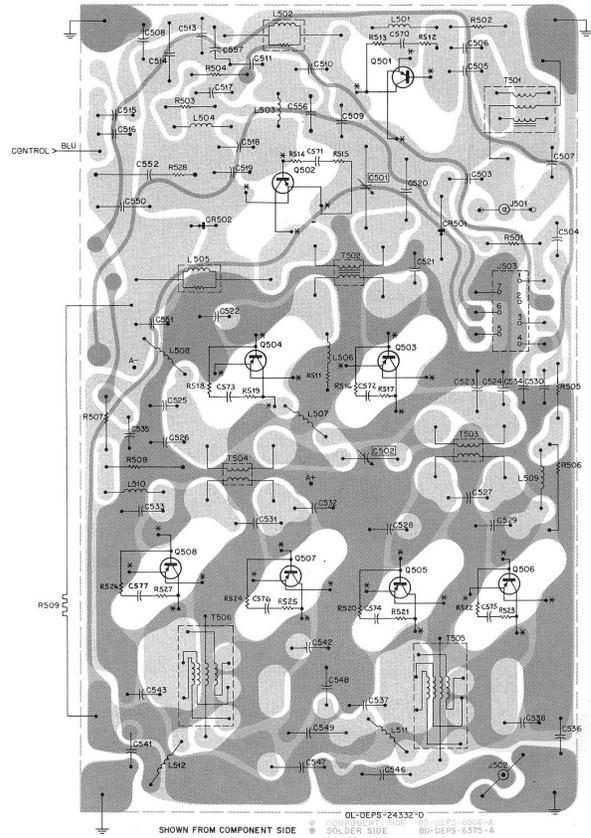
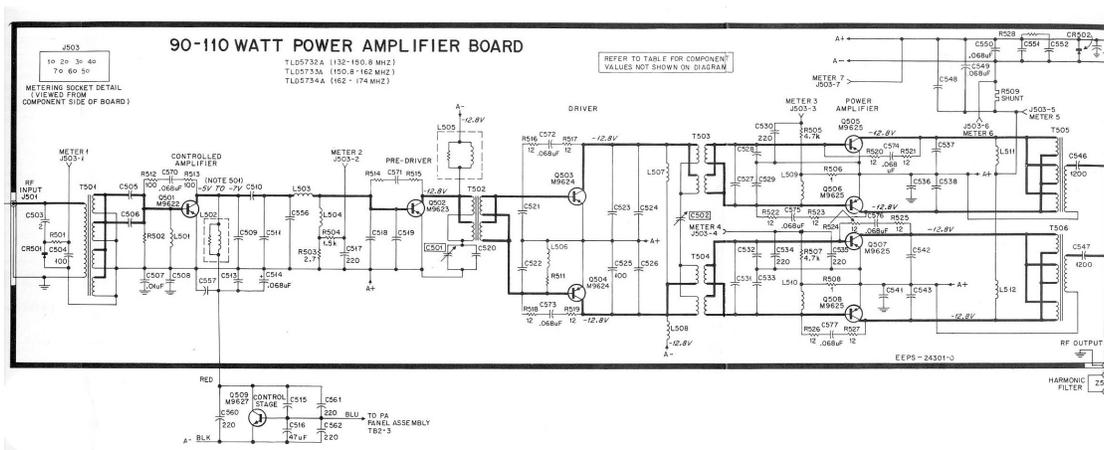
Taking the PA “drawer” apart shows the PA board and the power control board in the background. During alignment per the OEM manual, the board’s two controls, R610 and R611 are tricky to get to, especially the latter, which is called “power limit”. Checking out the schematic both pots are in series. The manual says to turn up the power control, then set the limit for 10-15% over rated output, and then turn the other pot (R610) back to spec. For SRG use this level is set 7 db below OEM spec because of the duty time and the fact this PA is not rated for continuous duty. Shown below is a good way to access both pots for this procedure.

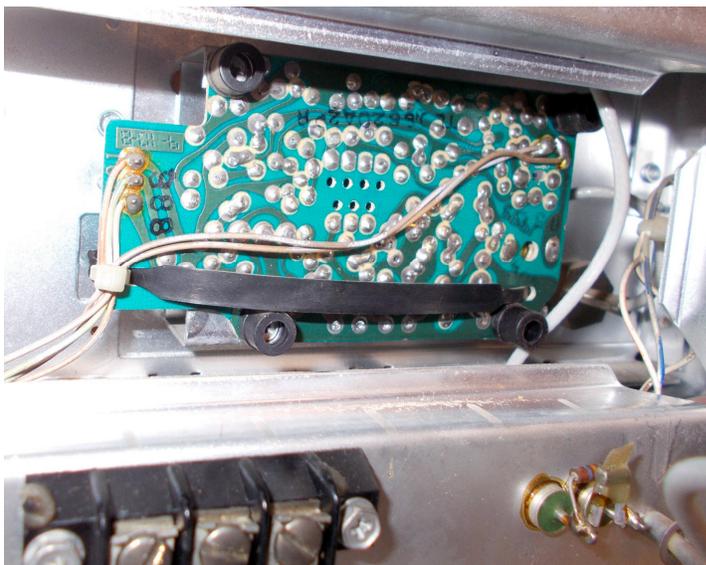
Here's a close-up of the power control board. There are five wires soldered on the board, being the A-, A+, control voltage, and two for the thermister, which is mounted externally to the board and on the chassis as seeing here in the lower right of the image.

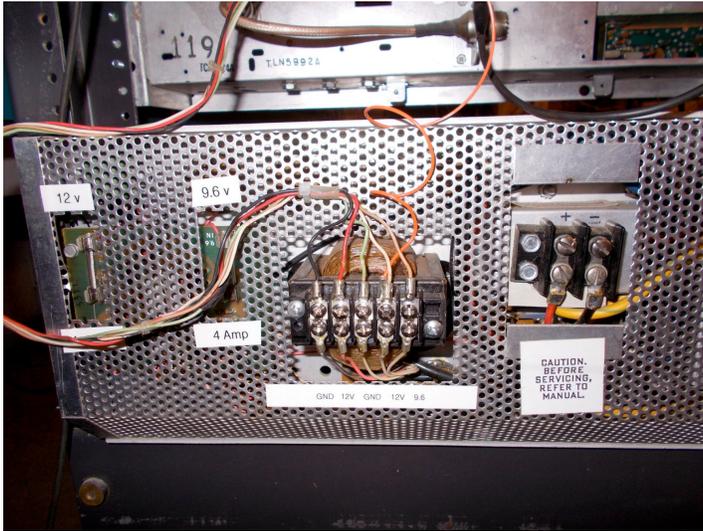
Even though the fuses (left) are for the 12 and 9.6 volts they are before the regulation. This is mentioned in the event you measure this point (blown fuse) will have the (high) unregulated voltage.

The Author removed the soldered power leads. With spade lug and a terminal block it provides easy troubleshooting in the event a chassis has a problem, such as a short. Plus it's a good point to add an accessory such as a fan or ID unit, etc.

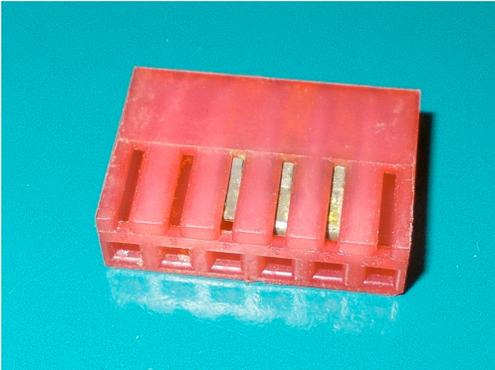
A problem found was intermittent power out. It was trouble shot to a badly corroded plug (and jack) on the interconnect board. P1004. Only three points are used, the A+, A- and control voltage.

Being a plug could not be found the alternative was to directly solder the wires to the pins of J1004 as shown below. The right image shows the corrosion on the board and chassis, likely from mice infestation.
