## Motorola Mitrek front end casting repair by Karl Shoemaker

### Introduction:

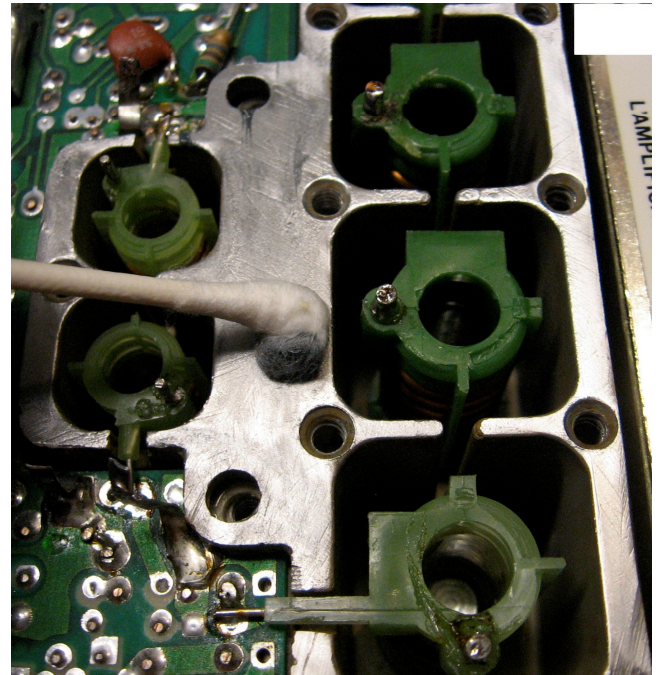
Here's a close-up of a coil's lead that was cleaned up of excessive solder. Note the edges of the casting have also been polished to remove any source of corrosion and PIM issues. Do this for the cover, too. Also, clean and blow out any debris that may have lodged on the bottom of the filter cavities. This will also clean out any "whiskers" that might have "grown" inside the cavities. This is a phenomena that happens with other brands of radios (GE Mastr-II for example). In this case there is enough (presumed) chemical reaction to the metals to cause "crystals" to form and grow across the cavity and "short" things out, causing complete failure to specification performance. It's unknown if it happens with this radio (at time of the research by the Author).

After the casting edges are cleaned and polished you can optionally apply a very thin coat of “interface” compound that solves the dissimilar metal corrosion issue. Using a Q-tip apply it on the casting anywhere it would come in contact with the cover. Apply it to the cover in the same areas. Make sure you don’t use the copper content type of compound because it would compound (pun intended) the PIM problem.
